# LIVING SHORELINES:

## Guidance for Sarasota Bay Watershed

Prepared for  
Sarasota Bay Estuary Program

June 2018

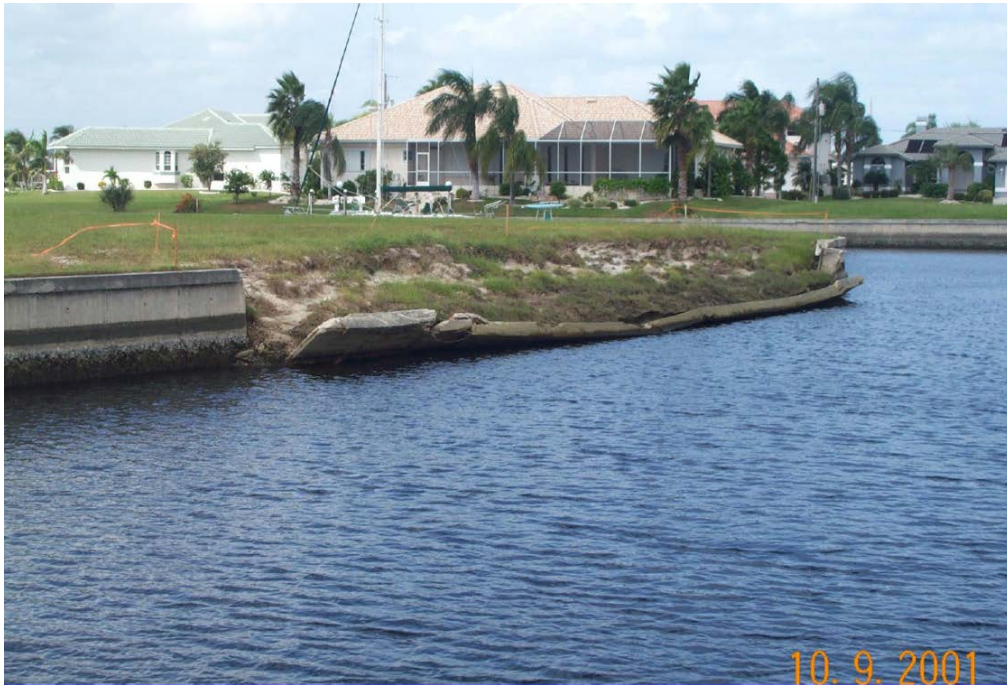
**Failed Seawall**

Vertical structures such as bulkheads and seawalls have been the most commonly used technique for shoreline protection and in some areas where there is high wave energy, they may be the most effective alternative. However, in many situations hardened structures are not always the best solution. Some of the detrimental effects of armoring include:

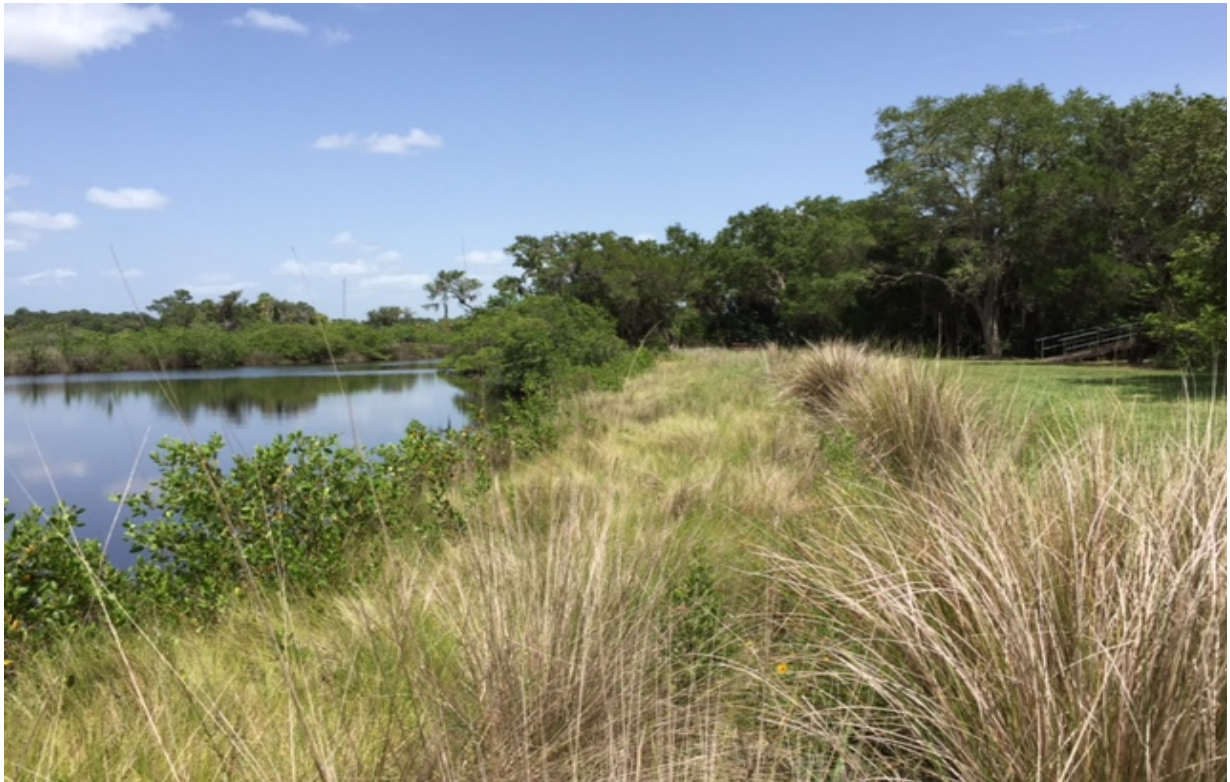
**Living Shoreline Solution after Removal of a Seawall at the Honi Hanta Girl Scout Camp in Bradenton, Florida**

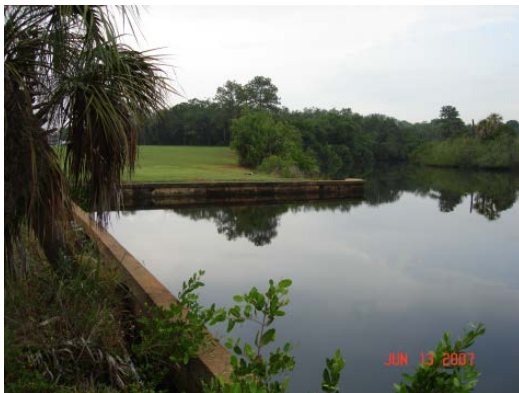
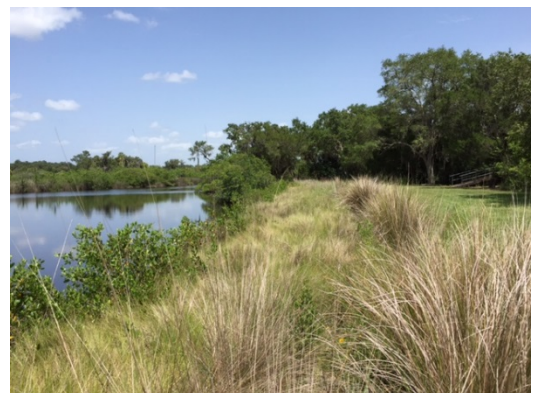
Before

After

The SBEP, in cooperation with the Girl Scouts of Gulfcoast Florida, Inc. (Girl Scouts), collaborated on a restoration project at Camp Honi Hanta, located on the Braden River. The selected habitat restoration project was accomplished through the removal of approximately 250 feet of seawall as well as the adjacent nuisance exotic vegetation, regarding of the slopes to reestablish a more natural bank slope, and the planting of native vegetation. Re-vegetation with native plants increased the water quality and wildlife habitat for this area. In this case, the restored banks were planted with native marsh grasses, with the help of the girl scouts, and within two years, mangroves trees naturally recruited the site, as anticipated. Approximately ½ acre of earthwork and 2 acres of exotic removal and re-vegetation were performed at this site. This restoration effort greatly improved juvenile fish habitat and help to increase fish production within Sarasota Bay. The overall benefits of this living shoreline project included the elimination

non-native plants, improved water quality, re-established natural shoreline gradient, and the recovery of mangrove and salt marsh communities. It is believed that the loss of these vital habitats and associated declines in water quality has resulted in historic reduction of fisheries in Sarasota Bay.

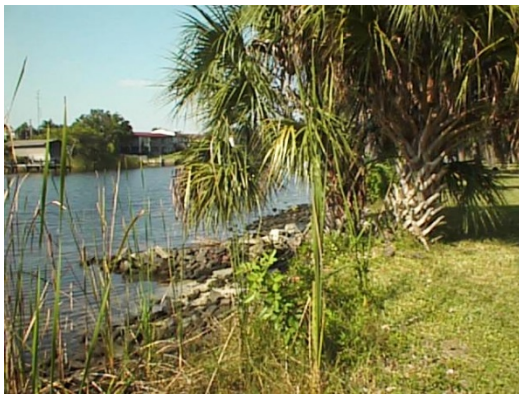
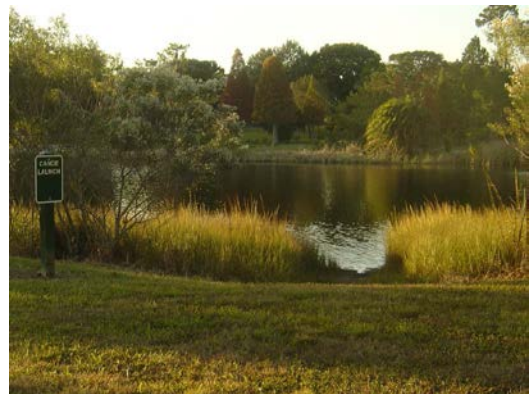
**Before**

**After (2 years post-installation)**

For this City of Tampa project, the banks were re-contoured to a gentle slope and Fibre™ Logs were placed water ward of the newly installed native wetland plants. The Fibre™ logs naturally breakdown over time (~18 months). By then the native vegetation is well established and protecting the shoreline.

Coir logs are biodegradable and made from coconut fiber. They can be staked in place and often are placed waterward of the plants and act to protect the vegetation and the substrate protection which gives the plants a chance to grow and coalesce (Section 4 - River Crest Park).

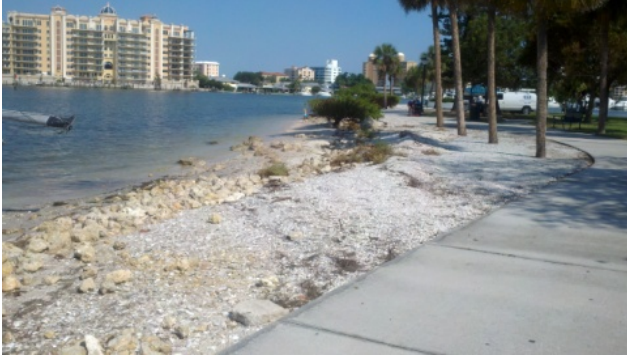
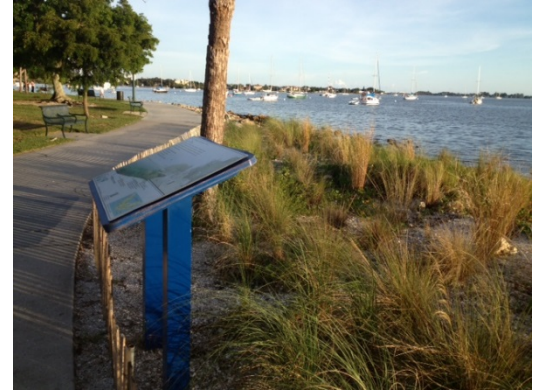
**Before**

**After**

The Sarasota Bay Estuary Program (SBEP) worked with the City of Sarasota to implement a living shoreline demonstration project at City Park in downtown Sarasota. For this project, ESA Scheda designed a planting palette of native wetland species that can be used to stabilize low energy shoreline areas in Sarasota Bay. The photos show the before and after results. The site has a large informational sign that explains the purpose of the de. The sign also included a Quick Response (QR) code that directs people using their smart phones to the SBEP's website and further educates the general public about the benefits of living shorelines.

The Guide also recommended pruning overhanging vegetation to there will be sunlight for the plants to grow. Grading the shoreline may be necessary prior to plant installation. (See Section 4 - Bayfront Park as an example of a vegetative living shoreline).

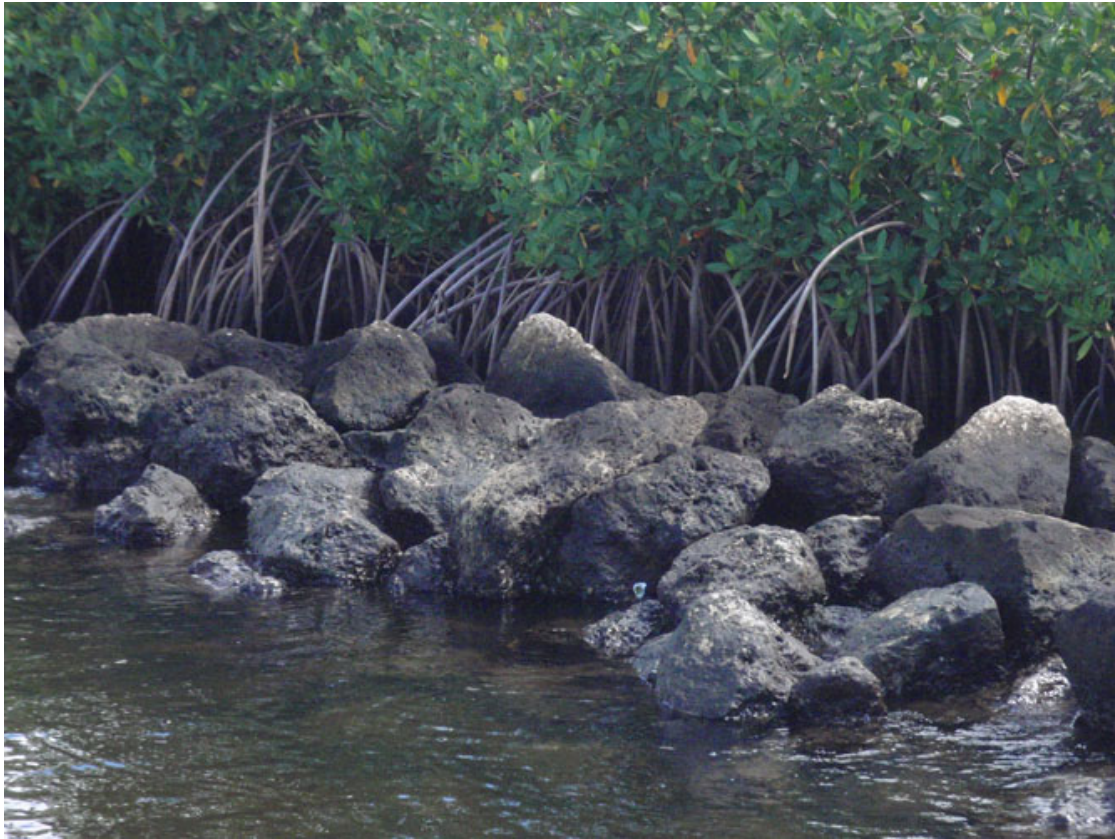
A 2,000 ft. long rock revetment was installed 8 ft. waterward of the existing seawall in the Lake Worth Lagoon. A filter fabric was placed under the rock and red mangroves were planted between the rock and seawall.

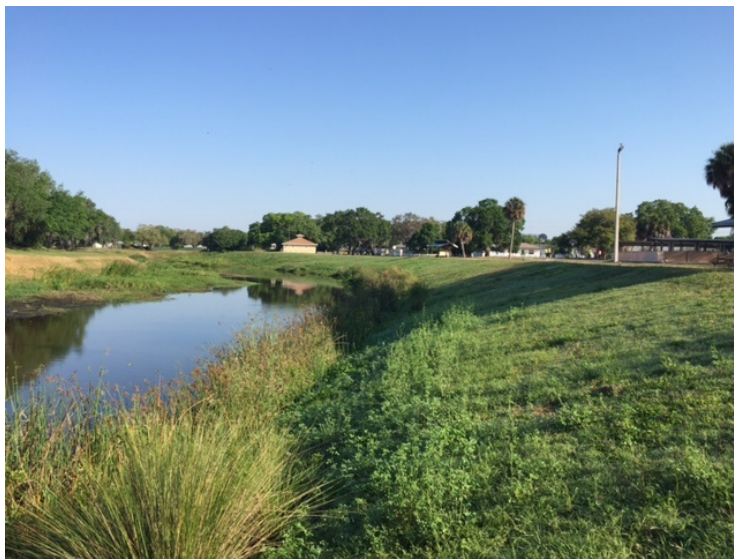
This project was designed with Geoweb™ material to stabilize the banks and allow for the installation of native freshwater wetland species. One year later, the resultant living shoreline slope is pictured below.

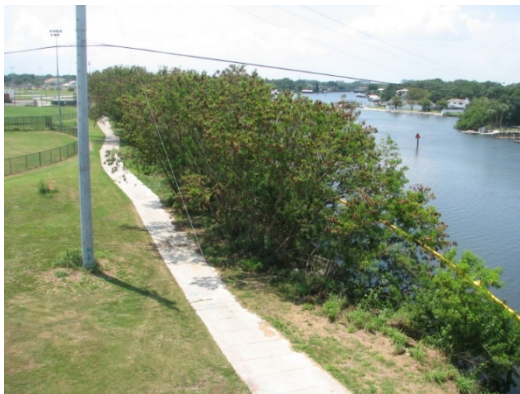
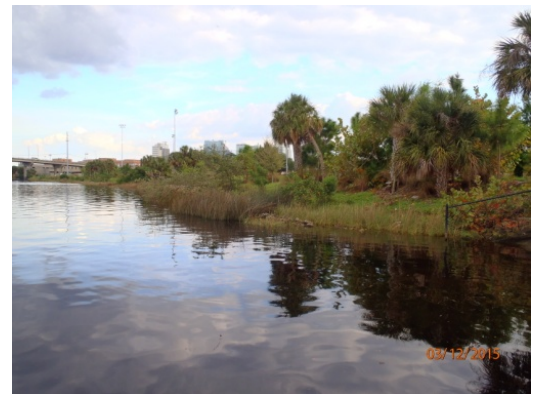
**Before**

**After**

This project involved the creation of a "living shoreline" to improve the existing conditions along the Hillsborough River shoreline adjacent to Stewart Middle School (SMS), near downtown Tampa. The river shoreline was severely eroded and infested with exotic vegetation, and thus was unusable for the teachers and students. An eco-friendly shoreline protection project, rather than the commonly used hardened shoreline profile that is typical for this section of the river, was selected to address this bank stabilization issue. This 1,900 linear foot project included a small rock revetment structure and associated planting trough, landward of the structure. In addition, geoweb was used to stabilize the 3:1 slope areas and in the 2:1 areas the geoweb was stacked into terracing feature. All of these areas were then planted with native vegetation by the students of SMS.

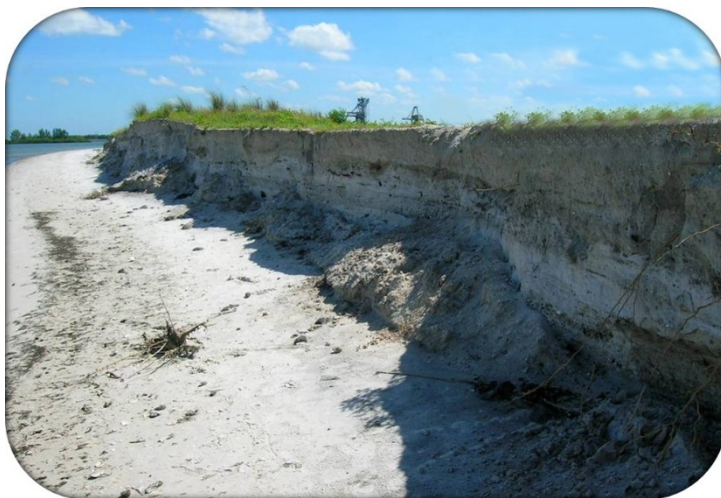
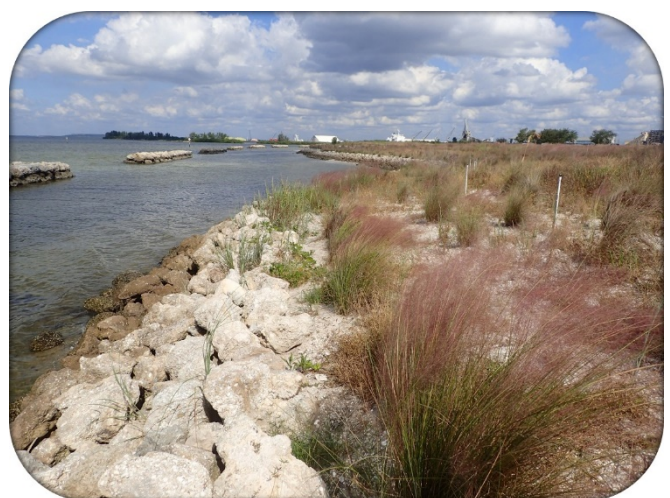
The restoration of the severely eroded shoreline at the Apollo Beach Nature Preserve required the design of breakwater structures, revetment stabilization, and incorporated a “living shoreline” feature. The project design included additional shoreline stabilization with planting of dune species and currently seagrass beds are thriving behind the breakwater features.

*Before*

*After*

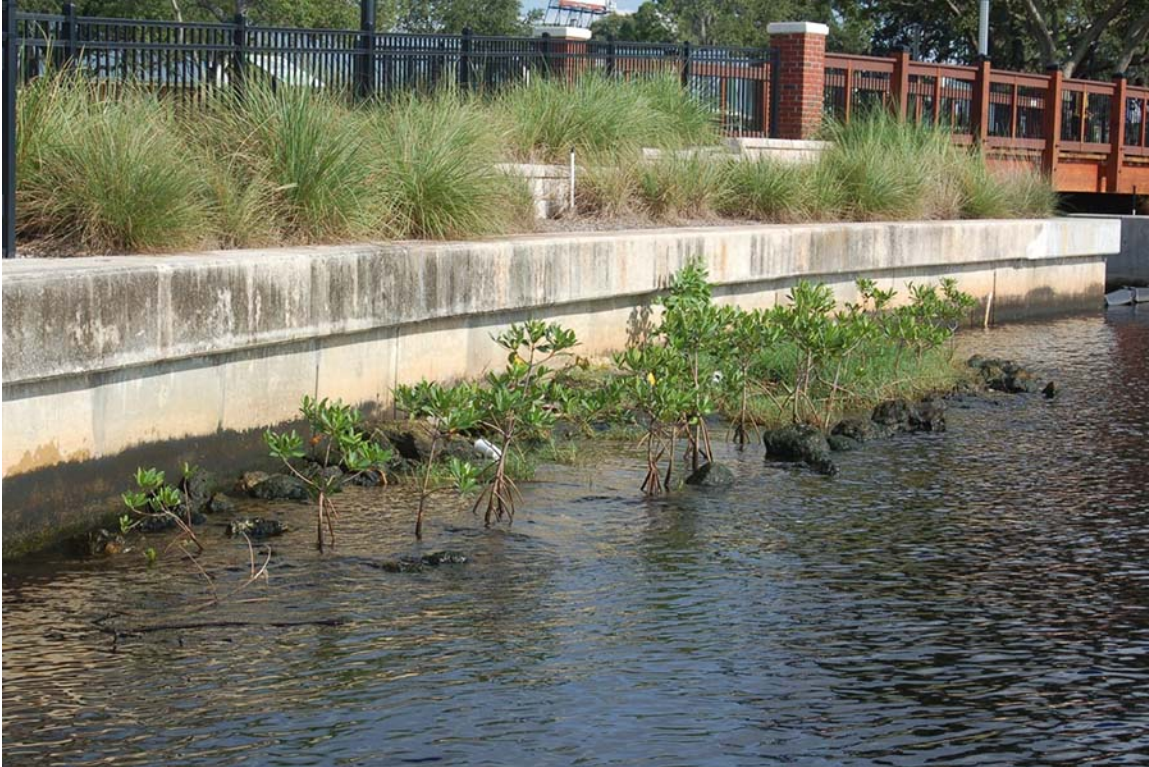
Unfortunately, there are hundreds of thousands of miles of seawall already in place in the US, and in some locations these cannot be removed due to the proximity of infrastructure and utilities or due to very high energy climates. In these cases, seawalls or bulkheads cannot easily be removed or replaced with a living shoreline option. These vertical walls provide little to no ecosystem benefits and do not effectively dissipate wave energy. To improve these circumstances, there are options that are superior to a vertical wall feature alone. These are commonly referred to as Seawall Enhancement Projects (SEP). SEPs include a variety of options that have been successfully deployed such as the addition of rock or rip-rap in front of the seawall. The mere placement of this rock will, at a minimum, help dissipate the wave energy and wave refraction properties which is superior to a vertical wall by itself. The rock also provides interstitial spaces for organisms to thrive. There are other design options that are viable, including the addition of “planters” within the rip-rap that are installed in front of an existing non-removable seawall. These planters require specific design considerations such as water level analysis and the incorporation of suitable sediment embedded within filter fabric to allow the installation of native plants. If these planters are installed within tidal regimes then it may be possible for the design of two distinct planters to capitalize on the high and low tide elevations.

If properly designed, these hybrid rock revetment features allow native plants to thrive thus providing habitat for many more species (fish, crustaceans, crabs, etc.). In the proper locations, mangrove trees can be planted within these planters and these trees will ultimately provide additional habitat opportunities including structure for bird roosting and even nesting opportunities. The red mangrove species, with its root propagule features, will also help hold the rock in place and the entire structure will provide energy dissipation to prolong the life of the seawall structure. If mangroves are likely to colonize the rip rap planters, then the resultant view shed needs to be discussed and understood. For many waterfront land owners, view shed is an extremely important objective and with the addition of a living shoreline or even a SEP feature, their views will potentially be limited if mangroves begin to thrive. To address this concern, mangrove trimming abilities should be incorporated into the regulatory permit process so the landowner can window the mangroves to allow views, while still providing many of beneficial attributes of a living shoreline.
